# Phase II of the Study on Low-Performance Rooftop Photovoltaic Plants in India gets Underway

## Case Study

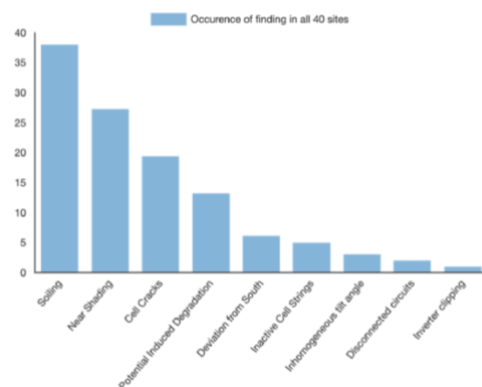
Table 1-2: Most frequent issues identified on the 40 rooftops

The most frequent issues identified in these installations were: build-up of dirt on modules (in 38 plants), strong shading (in 27 plants), and cracks on photovoltaic cells (in 19 plants) (Table 1-2).

In addition, we could verify that Potential Induced Degradation (PID), circuit disconnection and inverter unavailability could result in cumulative losses of up to 56 % of the plant's annual production.

After collecting evidence demonstrating that the performance of the analyzed plants could be much higher (from 5 % to even 50 % in some cases), PI Berlin launched 5 revamping proposals to partially mitigate the negative consequences of the various issues detected:

- Reordering of modules and strings.
- Increase in the cleaning frequency of modules.
- Replacement of modules under warranty.
- Increase in soil albedo.
- Reduction in the number of serial modules.
